**Situation Report – Cap Repair  
San Jacinto River Waste Pits Superfund Site  
Channelview, Harris County, Texas**

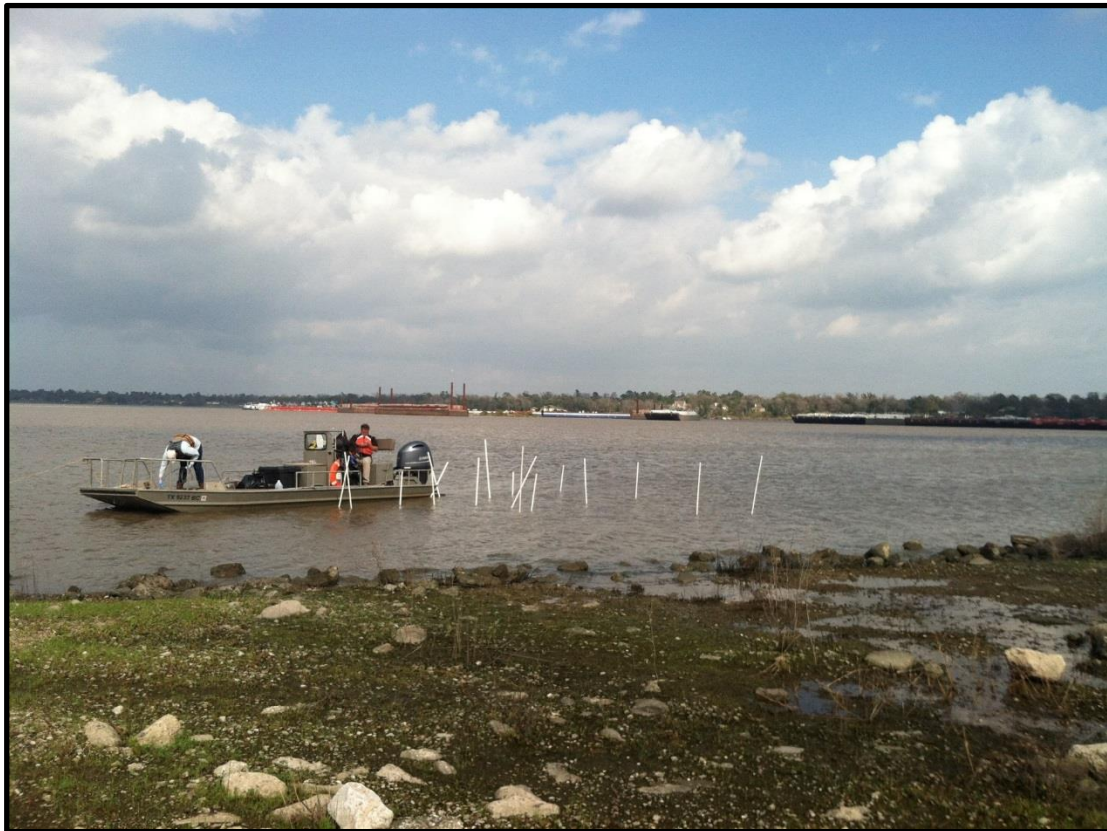
*December 10, 2015:* The EPA Dive Team completed an underwater inspection of the armor cap to assess how it has fared during the four years since construction. The divers inspected the armor cap visually and by side scan dual frequency sonar. In the northwest part of the cap near the shoreline a damaged area was identified that was at least 17-feet across.

*December 23, 2015:* following EPA approval of the Potentially Responsible Party's (PRP) delineation and sampling plan, the PRPs completed work to mark out the length and width of the damaged area, as well as collect sediment samples in and around the damaged area. **Picture #1** shows the damaged location, which was an irregularly shaped area approximately 20-feet by 25-feet. The surface of the damaged area was not depressed relative to the surrounding areas, and the armor material was still there, but there were gaps in the armor material, and instead of one continuous layer of armor rock, it consisted of mixed/alternating rock and sediment layers. The damaged area was in shallow water, approximately 8-inches to 18-inches deep.

- Prepare/mailout followup community fact sheet to inform the public on site events.
- Develop enhanced inspection plan – damaged area was essentially level with surrounding area and any similar area is not likely to be found by the bathymetric survey currently being done.
- Develop and implement addition cap protection from barge strikes - cause of damage is unknown, but is consistent with a barge/boat strike.

**PICTURE #1:** *Delineated damaged area. PVC pipes mark areas where cap was damaged.*

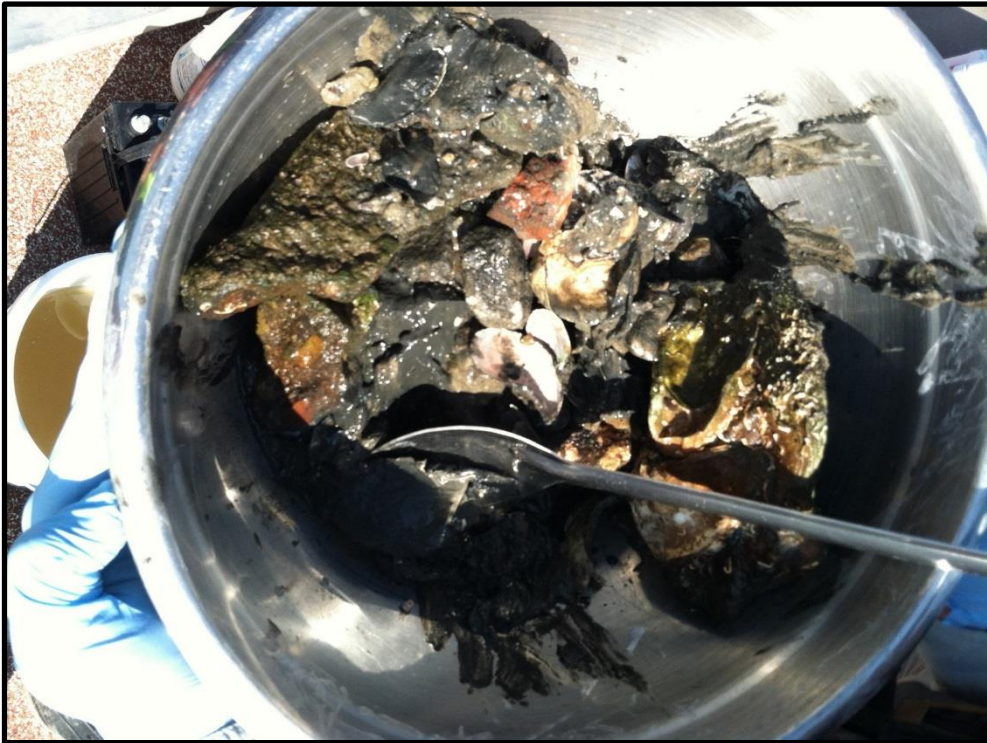
A total of 7 shallow (0-6 inches) sediment samples were collected within (3 samples) and outside (4 samples) of the damaged area. The samples within the damaged area contained rocks/aggregate as well as sediment and some shells – see **Picture #2**. The samples are being analyzed for dioxin /furan congeners. In addition, 3 split sample were collected by EPA's contractor in and outside of the damaged area for comparison to the PRPs sample results.

PICTURE #2: *First sample in damaged area; approximately 70 to 80 percent aggregate and live shell. Remainder soft sediments with organic smell.*

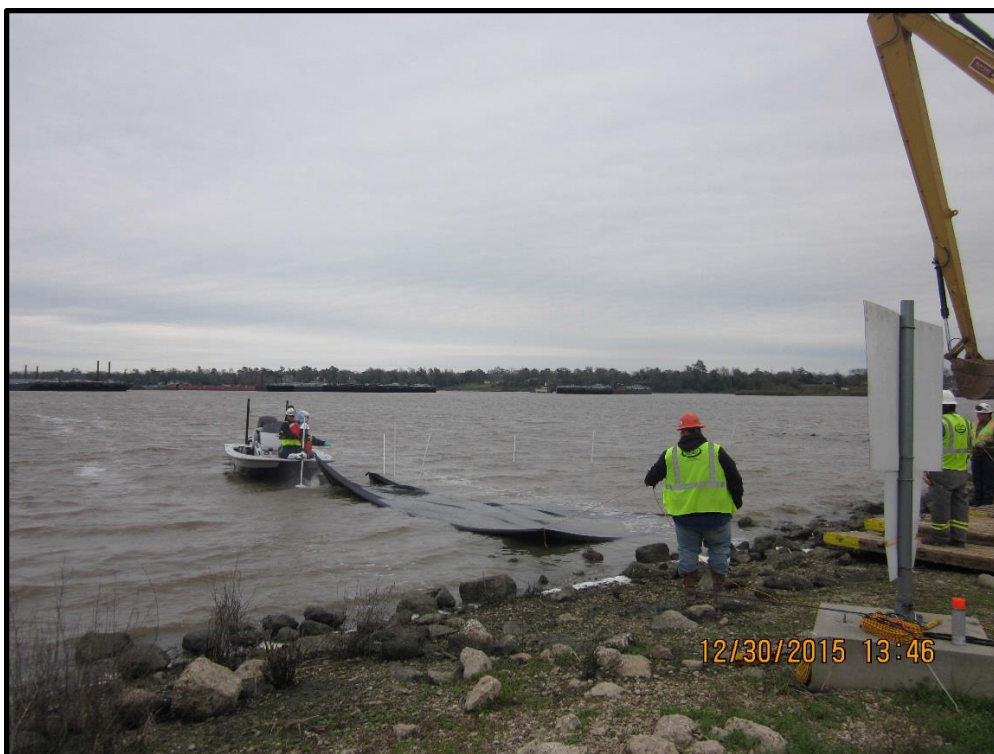
PICTURE #3: *Placing Geotextile over damaged area.*

*December 31, 2015:* Following EPA's approval of the repair plan, the PRPs completed work to lay an 8-ounce non-woven geotextile fabric over the damaged area (**Picture #3**) and cover it with a 1-foot minimum thickness layer of type C rock (8-inches median diameter) – **Picture #4**. Manual probing was done to confirm that the minimum rock thickness was achieved, and additional rock was added as needed.

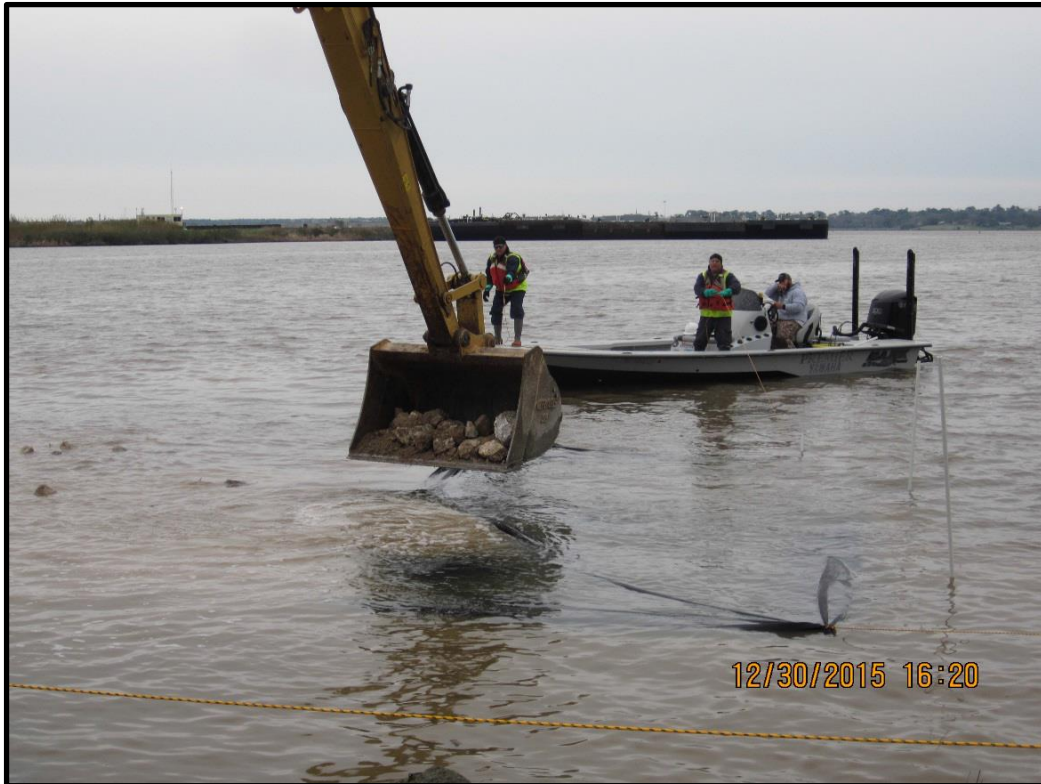
**PICTURE #4:** *Placing Type C rock on top of geotextile layer in damaged area.*
